SERVICE BULLETIN

SERVICE BULLETIN #235

MODELS: UNIVERSAL M25XPB, M25XPBC, M35B AND M35BC

SUBJECT: CAM SHAFT DRIVE TANG REINFORCING SLEEVE

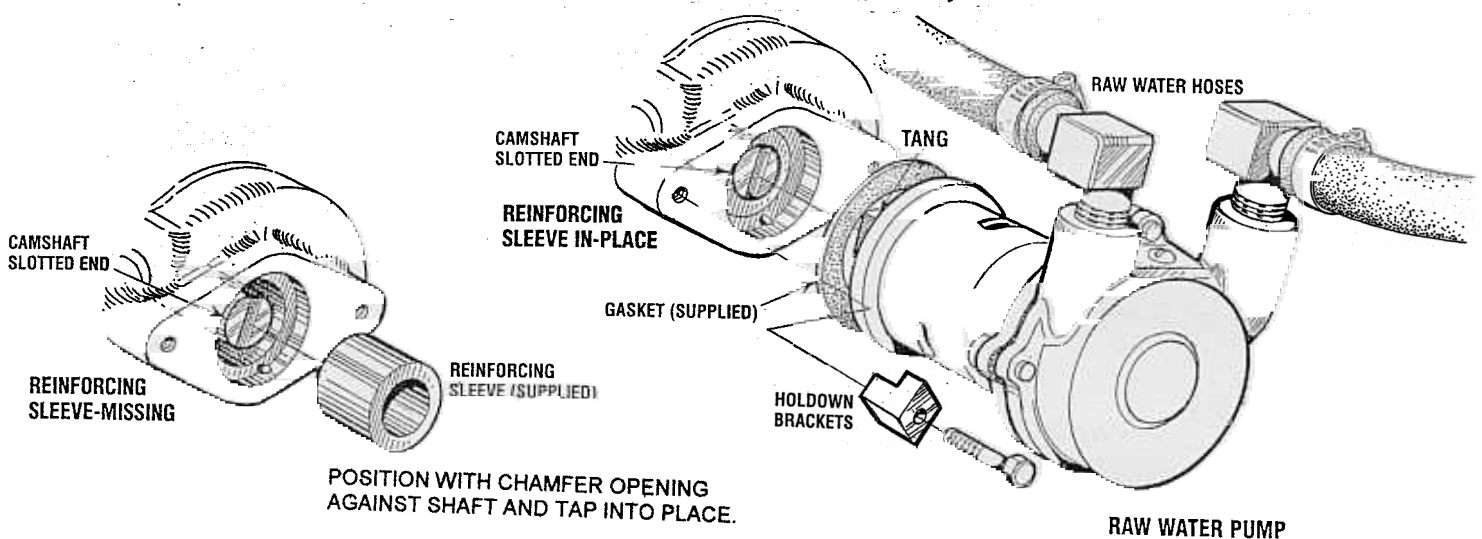
Random reports have been received from the field related to the failure of the sea water pump drive tang on the cam shafts of early Model "B" Series *UNIVERSALS* listed above.

These failures are related to early production models and it has been found that the sea water pump drive tang reinforcing sleeve had not been installed.

Owner/operators are advised to immediately remove the sea water pump off the front gear case of their engine and inspect the cam shaft sea water pump drive end to make sure it has this reinforcing sleeve. The illustrations show the cam shaft end with and without the reinforcing sleeve.

If the reinforcing sleeve is not present, contact the *WESTERBEKE CORPORATION* immediately at 508(823-7677 or email us at help@westerbeke.com referencing this Service Bulletin #235 and a sleeve and sea water pump mounting gasket will be sent at no charge. Please have the serial number of your engine available when making this request.

The reinforcing sleeve is easily installed as it is just a slight force fit fully over the sea water pump drive end of the cam shaft. Position the reinforcing sleeve squarely onto the end of the cam shaft and gently tap/push it fully onto the shaft end so it is flush with the end of the shaft.

Reinstall the sea water pump using the replacement mounting gasket supplied with the reinforcing sleeve.
